Navajo Abandoned Uranium Mine

Site Screen Report

Mine Name: **Frank Todecheenie No. 1**Mine ID: **87**

August 2011

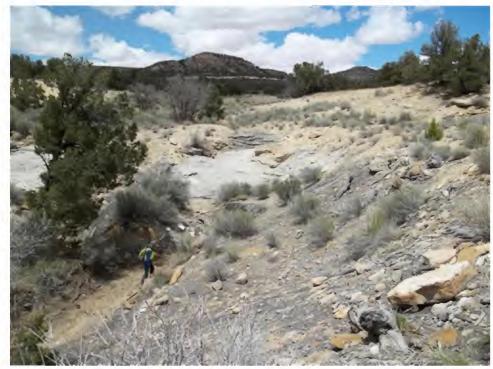
Photo 2: Mine Site #87; Drainage

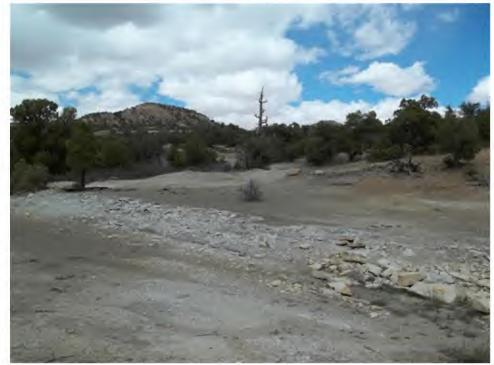
Northern section of site has 4 small waste rock piles, each 20 - 50 yd 3 surrounding potential loading area

Photo 3: Mine Site #87; Loading area and waste rock

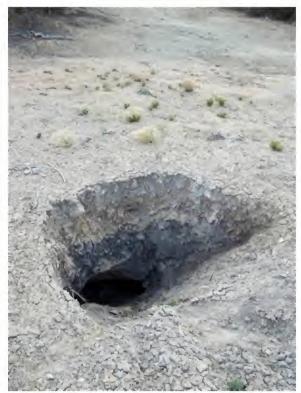
Possible collapsed adit

Photo 5: Mine Site #87; Possible collapsed adit/shaft

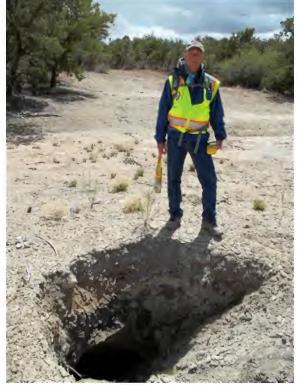
Photo 6: Mine Site #87; Possible collapsed adit/shaft
